Memorandum

To	Luke Moloney		
Copy to	Sue Hassett		
From	Adrian Roberts	Tel	+61 2 9239 7307
Subject	Crookwell Landfill - Detailed Design - Stage 1 - Design Basis Memorandum	Job no.	2125974

This Design Basis Memorandum (DBM) present the basis of design, including preliminary safety in design (SiD) assessment, for the detailed design of the Stage 1 landfill re-development works (Stage 1 works) at the Crookwell Landfill (the site) for Upper Lachlan Shire Council (Council).

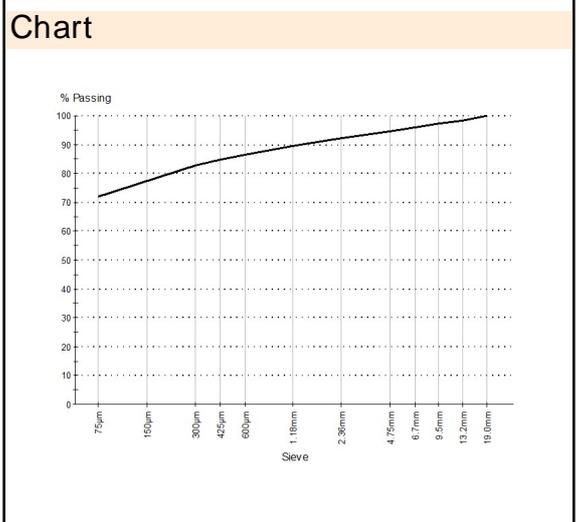
Description	Method	Result	Limits
Moisture Content (%)	AS 1289.2.1.1	19.1	
Date Tested		1/12/2016	
Sample History	AS 1289.1.1	Oven-dried	
Preparation	AS 1289.1.1	Dry Sieved	
Linear Shrinkage (%)	AS 1289.3.4.1	N/A	
Mould Length (mm)		0	
Crumbling		No	
Curling		No	
Cracking		No	
Liquid Limit (%)	AS 1289.3.1.1	46	
Method		Four Point	
Plastic Limit (%)	AS 1289.3.2.1	26	
Plasticity Index (%)	AS 1289.3.3.1	20	
Date Tested		7/12/2016	
Emerson Class Number	AS 1289.3.8.1	4	
Soil Description		CLAY: with sand	
Type of Water		Distilled	
Temperature of Water (°C)		24	
Date Tested		6/12/2016	
Standard Maximum Dry Density (t/m ³)	AS 1289.5.1.1	1.65	
Standard Optimum Moisture Content (%)		21.0	
Retained Sieve 19mm (%)		0	
Compactive Effort		Standard	
Date Tested		5/12/2016	
Coef of Permeability (m/sec)	AS 1289.6.7.3	1 E -09	
Mean Stress Level (kPa)		30	
Permeant Used		sydney tap	
Length (mm)		77.0	
Diameter (mm)		63.3	
Length/Diameter Ratio		1.20

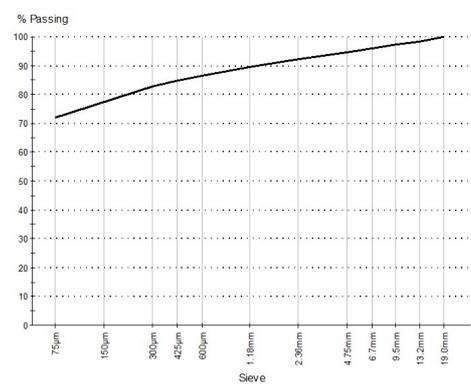
Chart

Description	Method	Result	Limits
Laboratory Moisture Ratio (%)		100.0	
Laboratory Density Ratio (%)		99.0	
CompactiveEffort		standard	
Method of Compaction		tamped	
Surcharge Applied (Kg)		0.0	
Pressure Applied (Kpa)		10	
Oversize Sieve (mm)		13.2	
Percentage Oversize (%)		2.0	
Moisture Content (%)		26.1	
Date Tested		6/12/2016

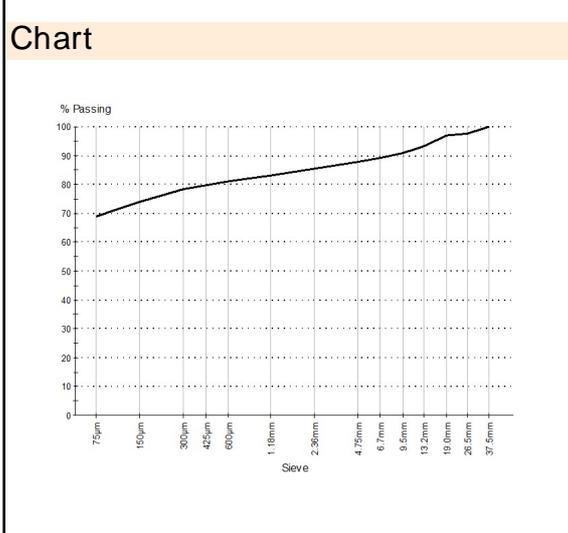
Description	Method	Result	Limits
Moisture Content (%)	AS 1289.2.1.1	20.8	
Date Tested		1/12/2016	
Sample History	AS 1289.1.1	Oven-dried	
Preparation	AS 1289.1.1	Dry Sieved	
Linear Shrinkage (%)	AS 1289.3.4.1	N/A	
Mould Length (mm)		0	
Crumbling		No	
Curling		No	
Cracking		No	
Liquid Limit (%)	AS 1289.3.1.1	44	
Method		Four Point	
Plastic Limit (%)	AS 1289.3.2.1	31	
Plasticity Index (%)	AS 1289.3.3.1	13	
Date Tested		7/12/2016	
Emerson Class Number	AS 1289.3.8.1	4	
Soil Description		Sandy SILT	
Type of Water		Distilled	
Temperature of Water (°C)		24	
Date Tested		6/12/2016	
Standard Maximum Dry Density (t/m ³)	AS 1289.5.1.1	1.64	
Standard Optimum Moisture Content (%)		22.0	
Retained Sieve 19mm (%)		3	
Compactive Effort		Standard	
Date Tested		5/12/2016	
Coef of Permeability (m/sec)	AS 1289.6.7.3	7 E -10	
Mean Stress Level (kPa)		30	
Permeant Used		Sydney Tap	
Length (mm)		74.8	
Diameter (mm)		63.3	
Length/Diameter Ratio		1.20

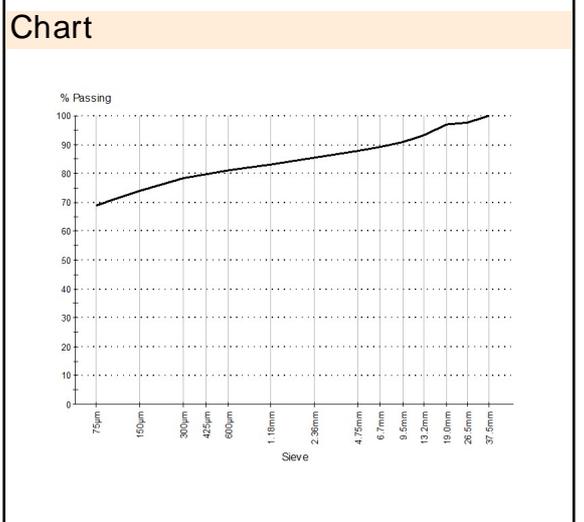
Description	Method	Result	Limits
Laboratory Moisture Ratio (%)		100.5	
Laboratory Density Ratio (%)		99.5	
CompactiveEffort		Standard	
Method of Compaction		tamped	
Surcharge Applied (Kg)		0.0	
Pressure Applied (Kpa)		10	
Oversize Sieve (mm)		13.2	
Percentage Oversize (%)		7.0	
Moisture Content (%)		25.8	
Date Tested		6/12/2016

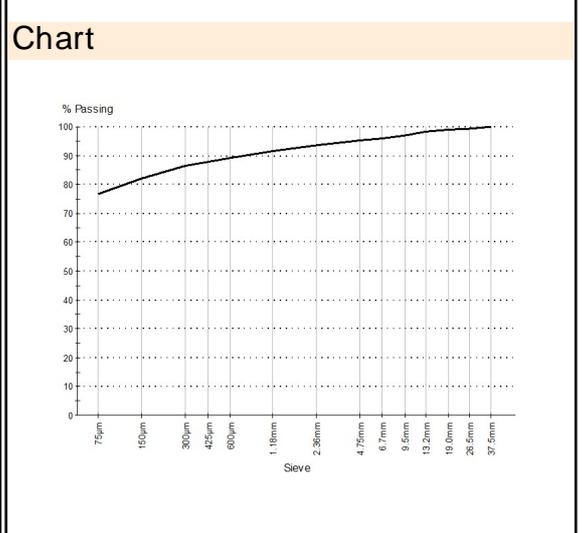
Description	Method	Result	Limits
Moisture Content (%)	AS 1289.2.1.1	21.8	
Date Tested		1/12/2016	
Sample History	AS 1289.1.1	Oven-dried	
Preparation	AS 1289.1.1	Dry Sieved	
Linear Shrinkage (%)	AS 1289.3.4.1	N/A	
Mould Length (mm)		0	
Crumbling		No	
Curling		No	
Cracking		No	
Liquid Limit (%)	AS 1289.3.1.1	47	
Method		Four Point	
Plastic Limit (%)	AS 1289.3.2.1	27	
Plasticity Index (%)	AS 1289.3.3.1	20	
Date Tested		7/12/2016	
Emerson Class Number	AS 1289.3.8.1	4	
Soil Description		CLAY: with sand	
Type of Water		Distilled	
Temperature of Water (°C)		24	
Date Tested		6/12/2016	
Standard Maximum Dry Density (t/m³)	AS 1289.5.1.1	1.60	
Standard Optimum Moisture Content (%)		23.0	
Retained Sieve 19.0mm (%)		1	
Compactive Effort		Standard	
Date Tested		5/12/2016	
Coef of Permeability (m/sec)	AS 1289.6.7.3	1 E -09	
Mean Stress Level (kPa)		30	
Permeant Used		Sydney Tap	
Length (mm)		74.8	
Diameter (mm)		63.2	
Length/Diameter Ratio		1.20

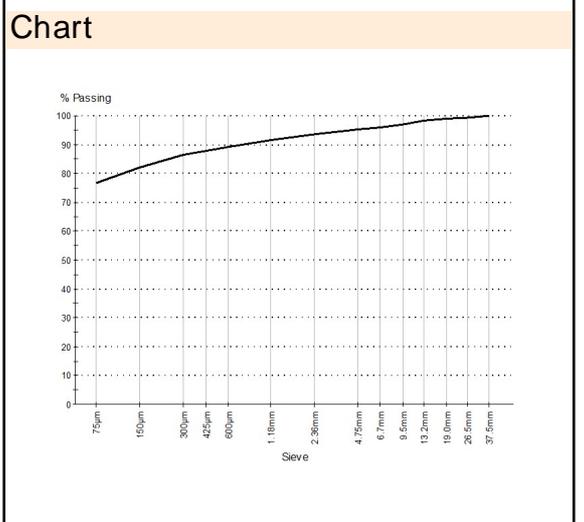
Description	Method	Result	Limits
Laboratory Moisture Ratio (%)		100.0	
Laboratory Density Ratio (%)		100.0	
CompactiveEffort		standard	
Method of Compaction		tamped	
Surcharge Applied (Kg)		0.0	
Pressure Applied (Kpa)		10	
Oversize Sieve (mm)		13.2	
Percentage Oversize (%)		2.0	
Moisture Content (%)		26.5

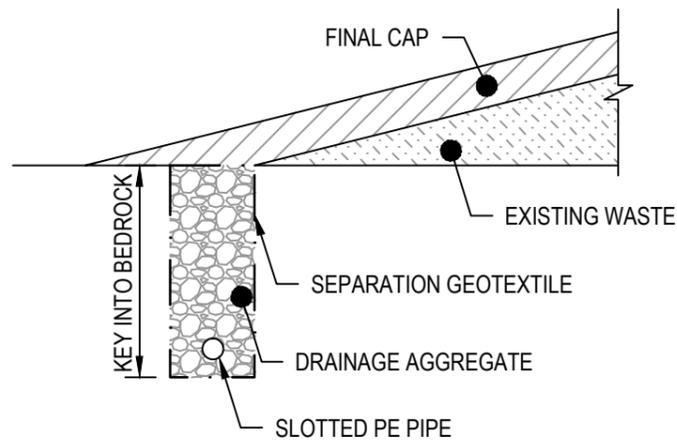
1 DETAIL
SCALE 1 : 50

**LEACHATE INTERCEPTION TRENCH
TYPICAL DETAIL**
