# Upper Lachlan Shire Council

## Feasibility Study

### Crookwell Landfill

June 2015

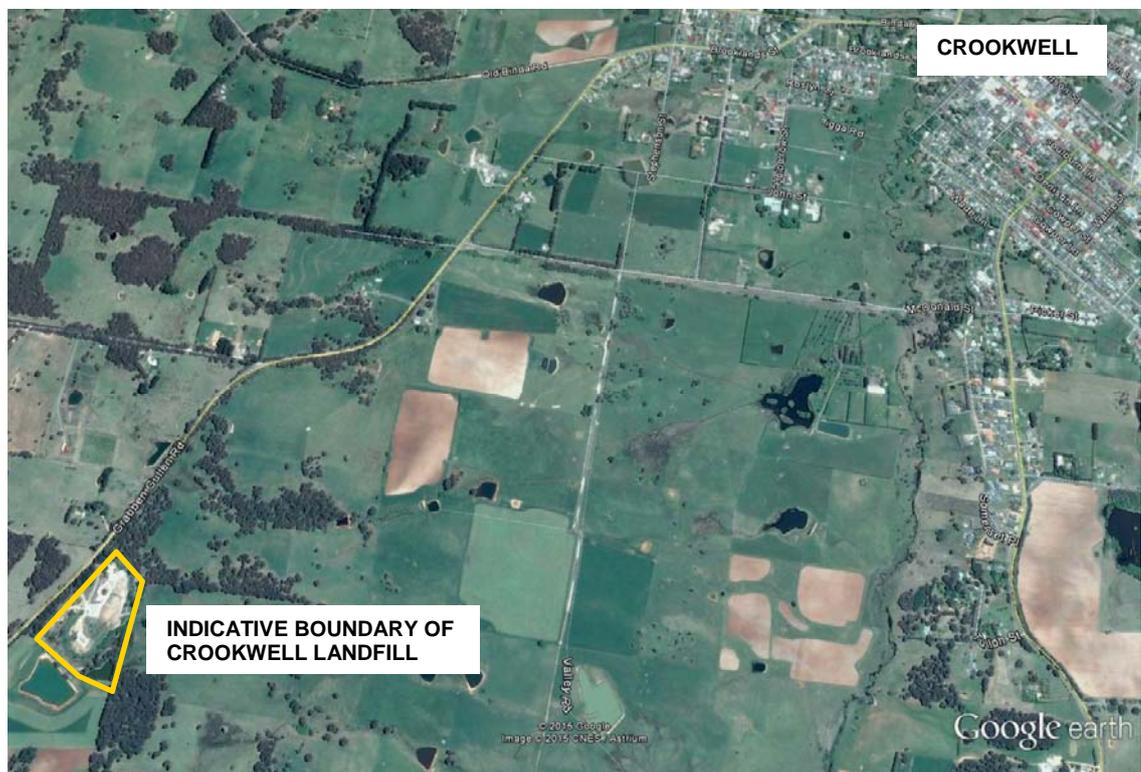
Figure 1 Locality

Crookwell Landfill is located on Grabben Gullen Road, Crookwell, approximately 3.5 km south-west from the township of Crookwell. Figure 1 shows the location of Crookwell landfill with regard to the township of Crookwell. The land on which the Crookwell landfill is located is approximately 7.7 ha in area.

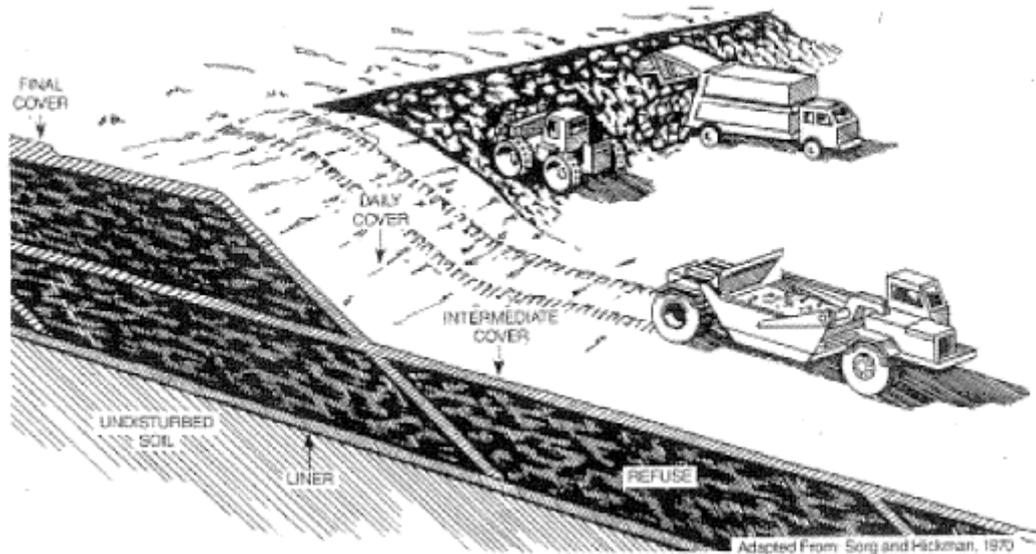
Figure 2 Area method of landfilling <sup>(1)</sup>

According to the LEMP, an area method style of landfilling (refer Figure 2) has traditionally been employed at the site as opposed to trench or gully method (refer Figure 3). However, some trench landfill was used for certain special waste such as for animal carcasses.

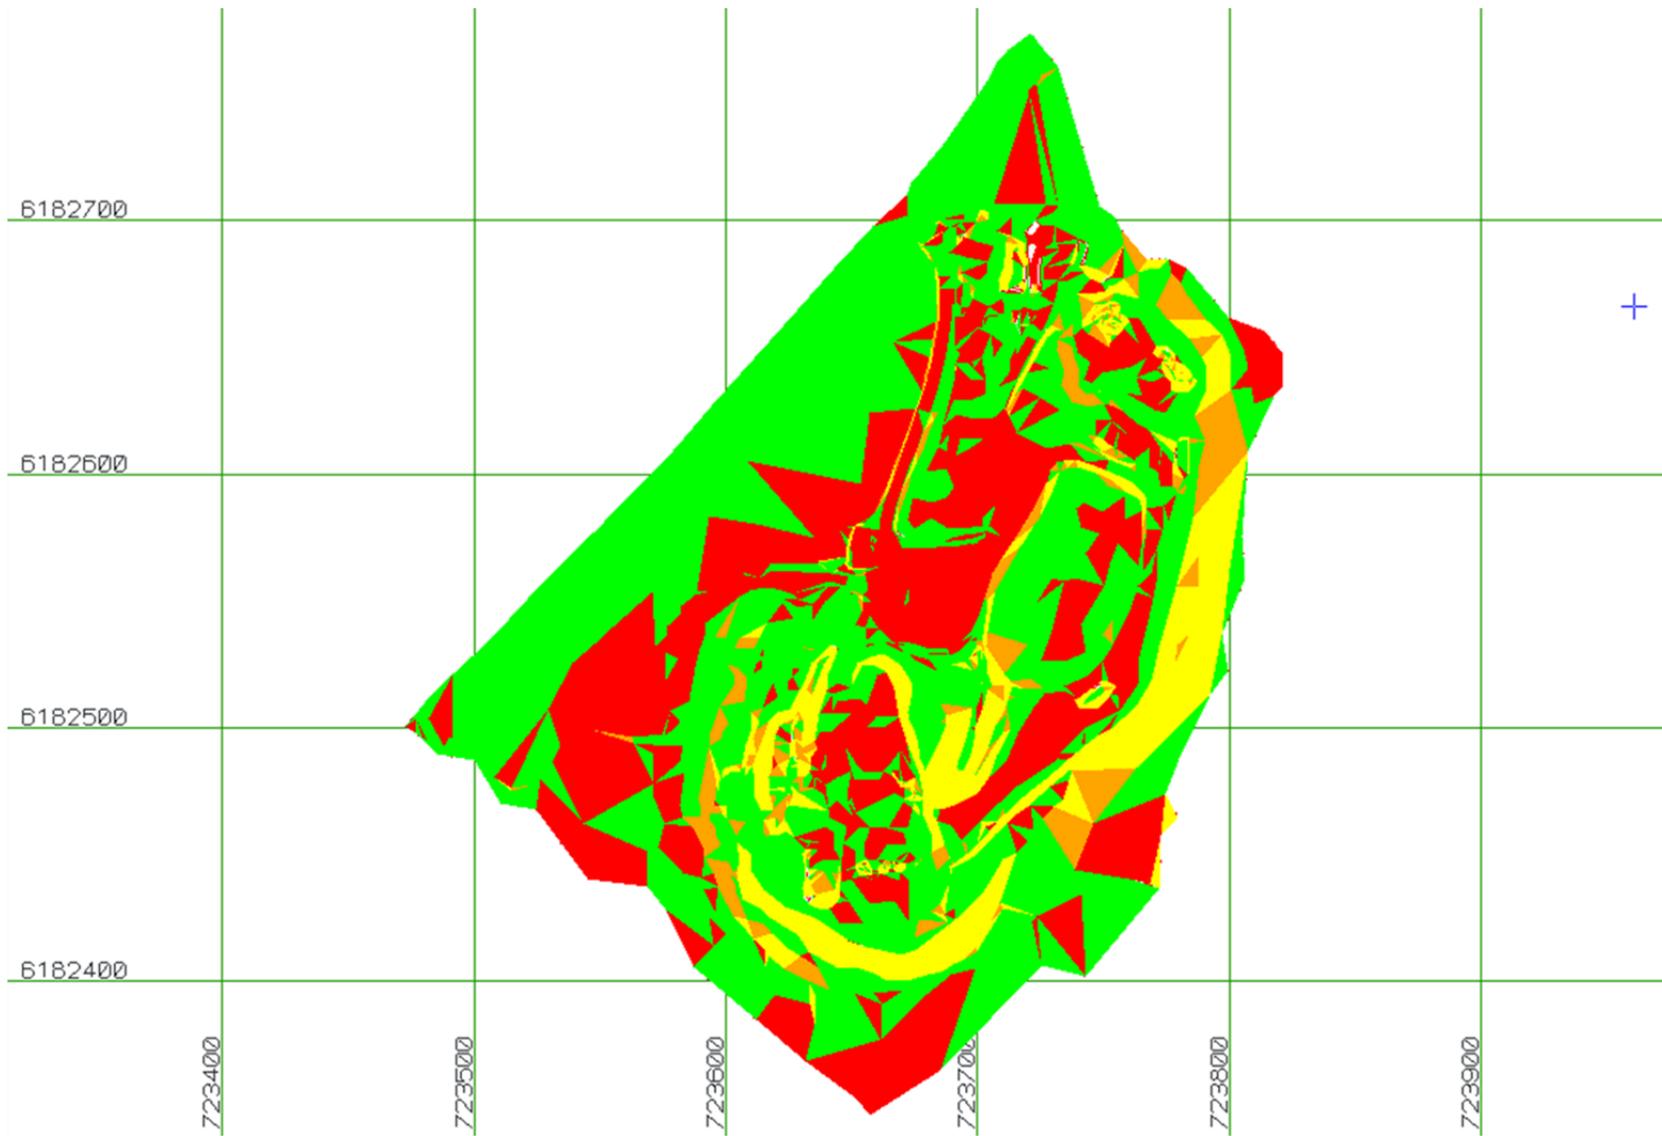
Figure 4 Slope analysis of existing landform

As mentioned in section 2.7, GHD undertook a slope analysis of the latest survey received (LandTeam, 2015) using a 3D modelling package (12D model, version 11). It was noted that the eastern and western batters were over steepened and exceeded slopes of 1(V):3(H); with parts of the batter having slopes steeper than 1(V):2(H).

Slope range, 1 (V) : X (H)	Colour	Assessment
Less than 3	Yellow	Considered too steep
3 to 4	Orange	Not preferred due to maintenance issue
4 to 20	Green	Preferred
Greater than 20	Red	Considered too flat

The surface created by the landfilling operations varies in shape and slope. A slope analysis of the latest survey received (LandTeam, 2015) has been undertaken using a 3D modelling package (12D model, version 11). It was noted that the eastern and western batters were over steepened and exceeded slopes of 1(V):3(H), with parts of the batter having slopes steeper than 1(V):2(H).

Maintaining slopes between 1(V):20(H) and 1(V):4(H) is essential for erosion and sediment control, allowing the capping layer to be effectively maintained whilst promoting stormwater runoff. Generally, slopes flatter than 1(V):20(H) have high risk of promoting excessive ponding which leads to excess infiltration through the cap resulting in the generation of large, undesirable quantities of leachate.

Maintaining a batter slope greater than 1(V):4(H) has the potential to promote issues associated with slope stability and may result in failure of the final cap through veneer failure of the capping materials.

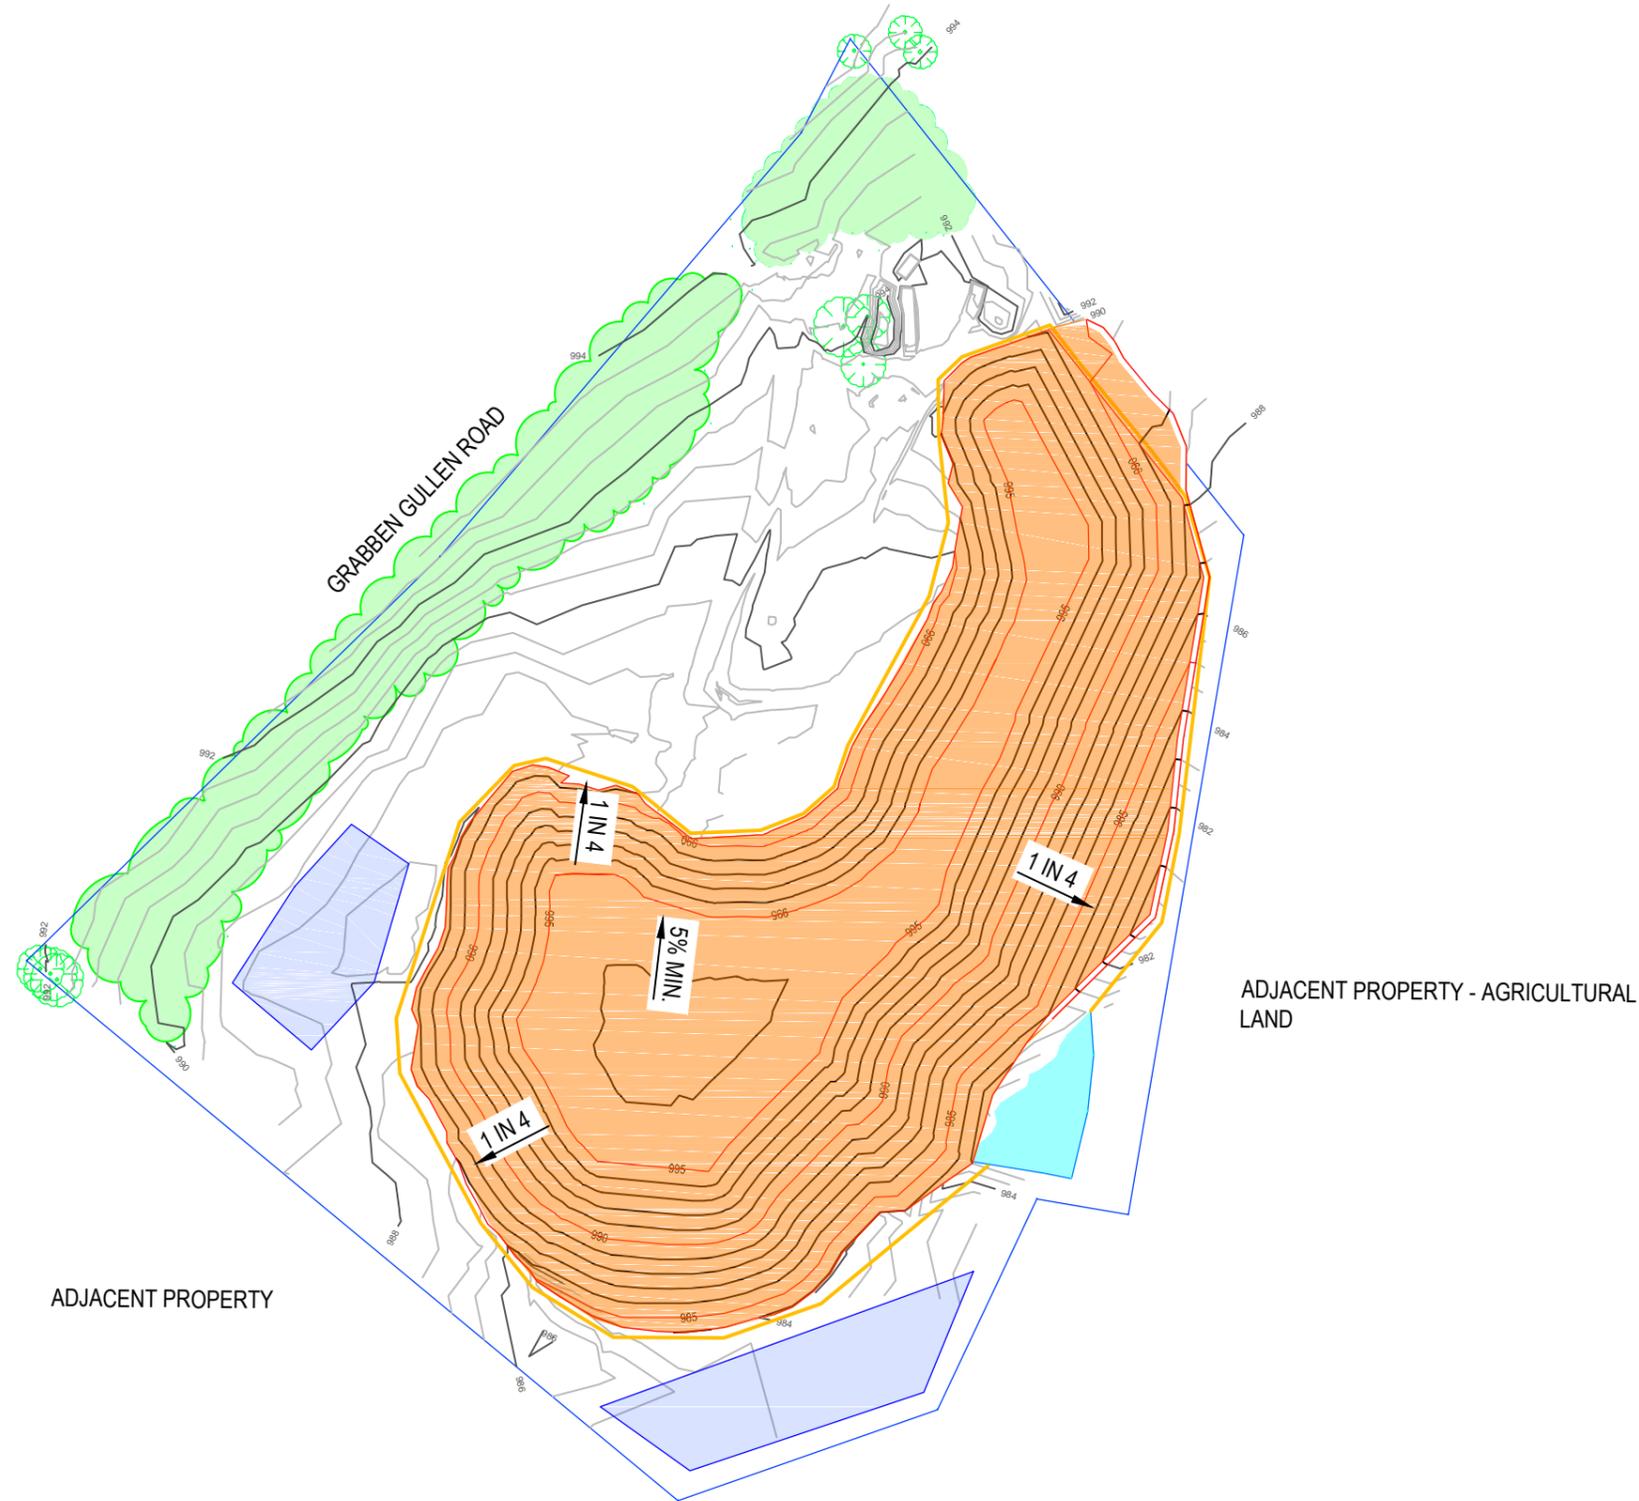
approved (PD) . . . . . **SK002**

WASTE RELOCATION REQUIRED	21,500 m <sup>3</sup>
TOTAL CAPACITY PROVIDED	40,500 m <sup>3</sup>
WASTE CAPACITY REMAINING	19,000 m <sup>3</sup>
FINAL LANDFORM CAP AREA	33,700 m <sup>2</sup>

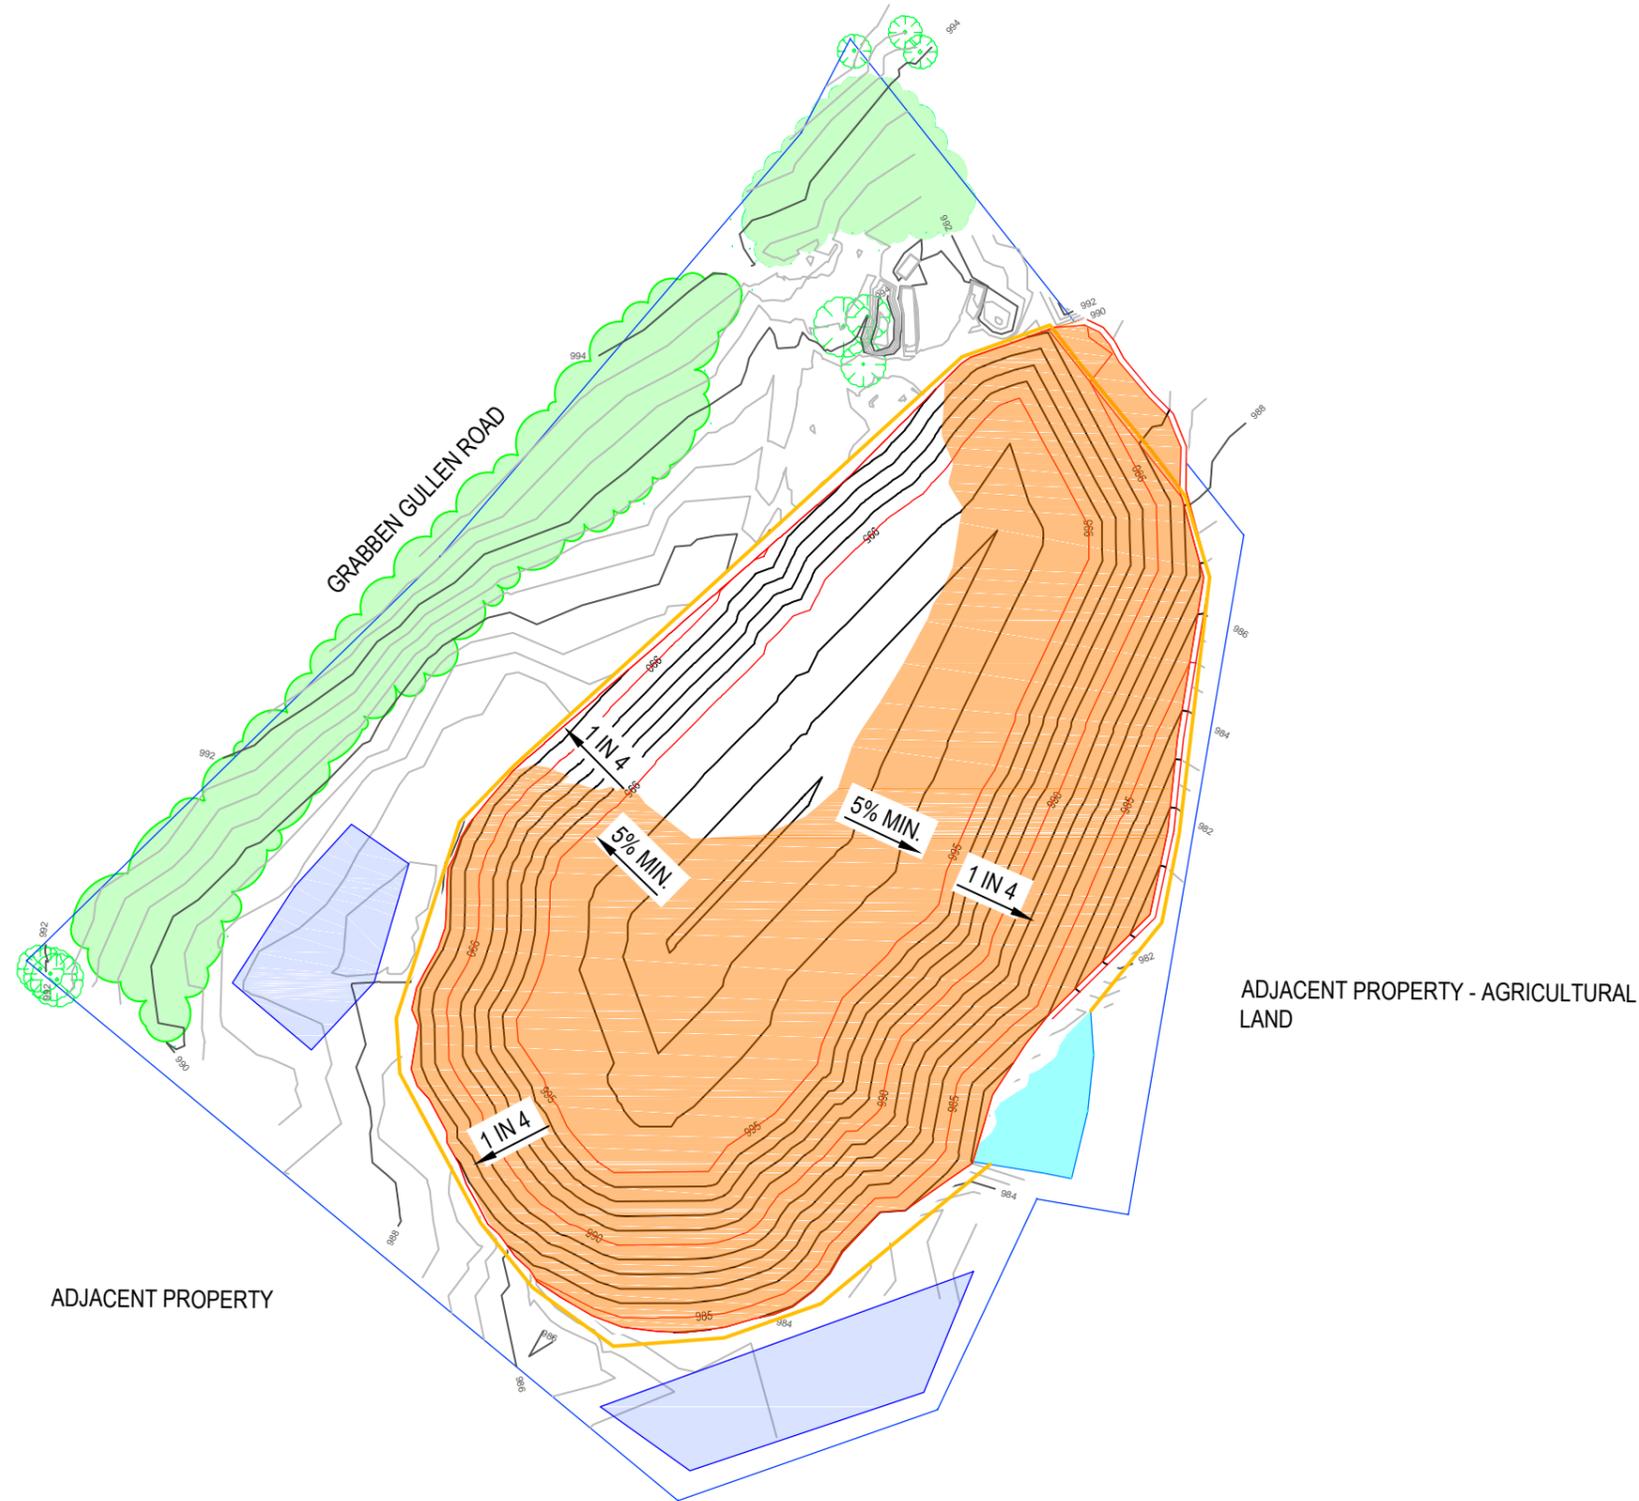
approved (PD) . . . . . **SK003**

WASTE RELOCATION REQUIRED	21,500 m <sup>3</sup>
TOTAL CAPACITY PROVIDED	97,500 m <sup>3</sup>
WASTE CAPACITY REMAINING	76,000 m <sup>3</sup>
FINAL LANDFORM CAP AREA	40,500 m <sup>2</sup>
EXTENSION AREA	6,850 m <sup>2</sup>

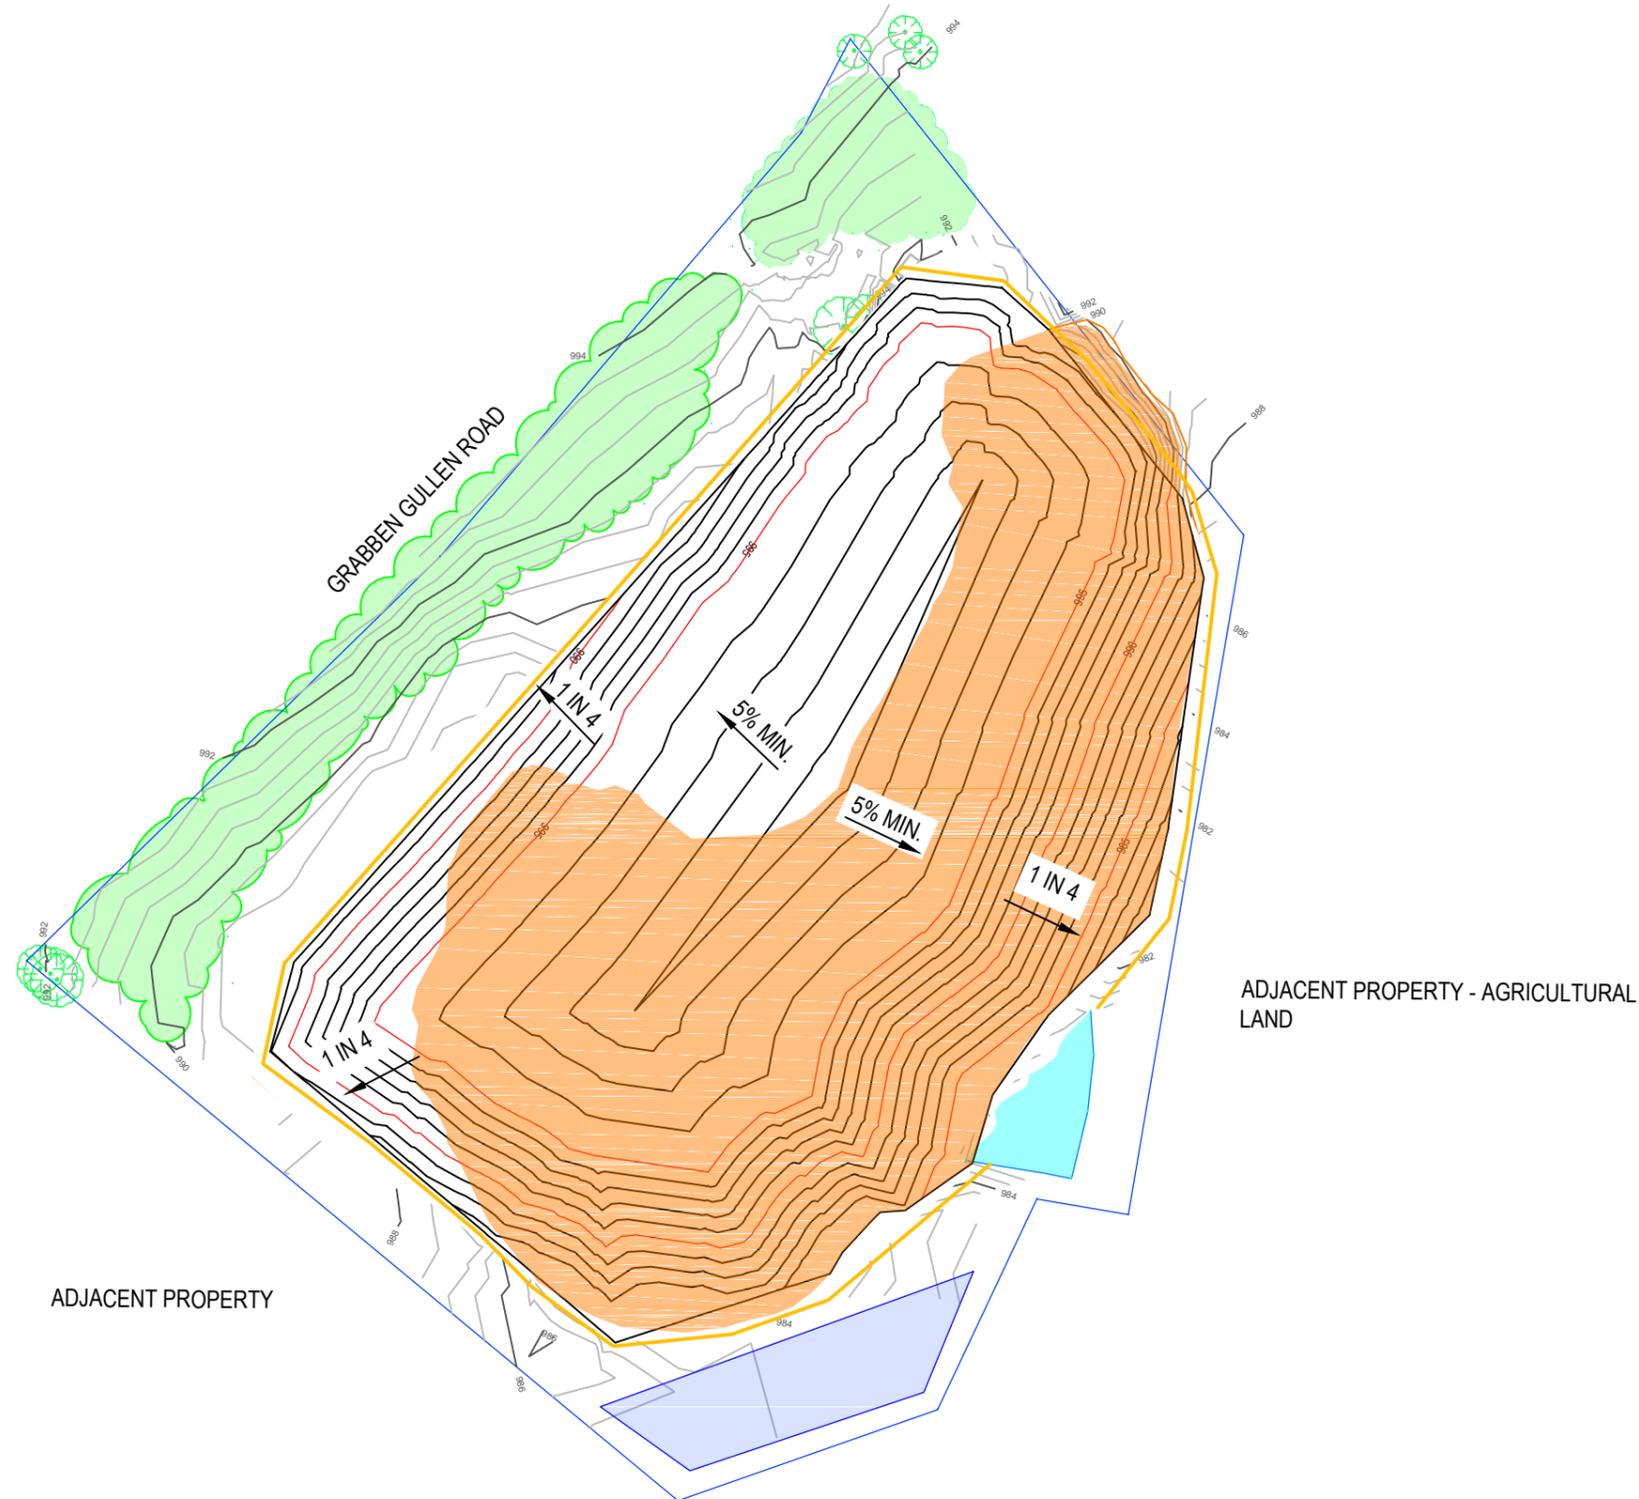
approved (PD) . . . . . **SK004**

WASTE RELOCATION REQUIRED	14,000 m <sup>3</sup>
TOTAL CAPACITY PROVIDED	163,200 m <sup>3</sup>
WASTE CAPACITY REMAINING	149,700 m <sup>3</sup>
FINAL LANDFORM CAP AREA	46,000 m <sup>2</sup>
EXTENSION AREA	12,300 m <sup>2</sup>

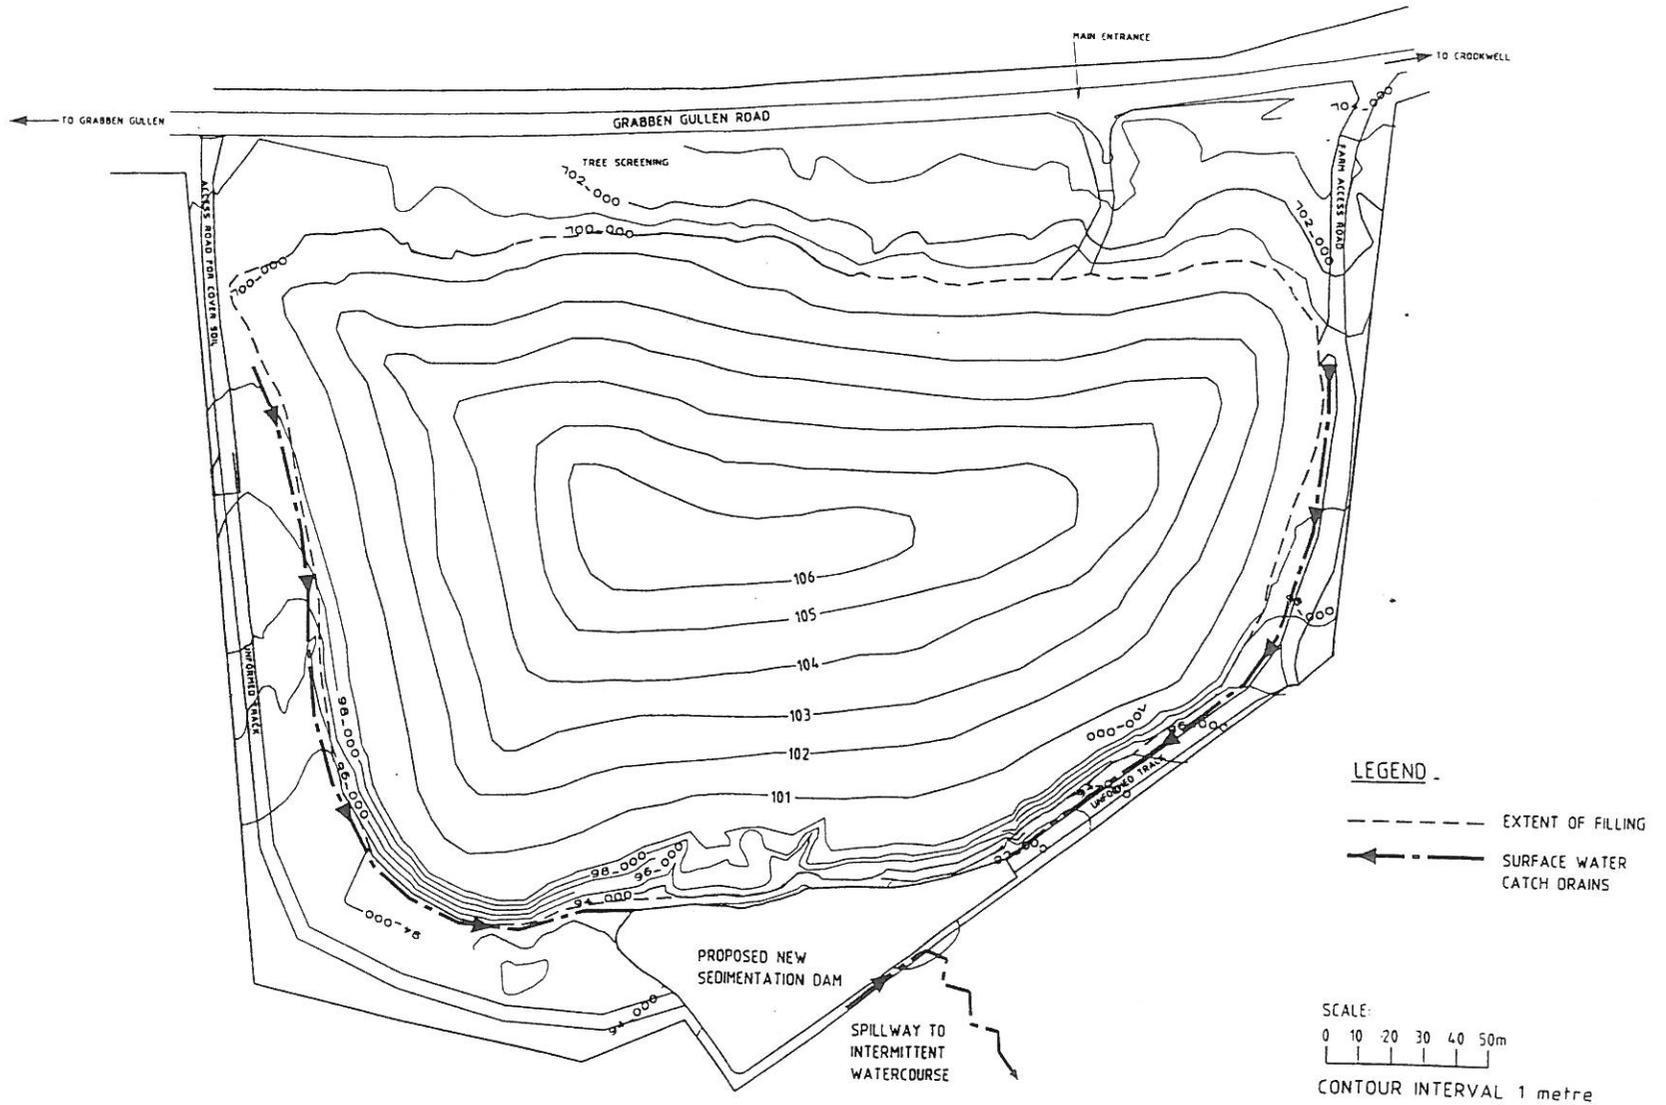
FIGURE 5

CROOKWELL SHIRE COUNCIL  
 CROOKWELL LANDFILL DEPOT - PROPOSED FINAL LANDFORM

It is noted that the footprint assumed here is smaller than the footprint of the proposed final landform proposed in the LEMP (Appendix B) and mostly continues landfilling on existing disturbed area to form a shape that would promote shedding of water and produce a natural mound. Additionally, some minor excavation works within the proposed cell areas, which may be required to provide a suitable surface for the installation of any future lining and leachate collection system, may provide a small amount of additional capacity.
